Limited Visual Dam Safety Inspections

OA00137

Oahu Reservoir No. 155

May 2006

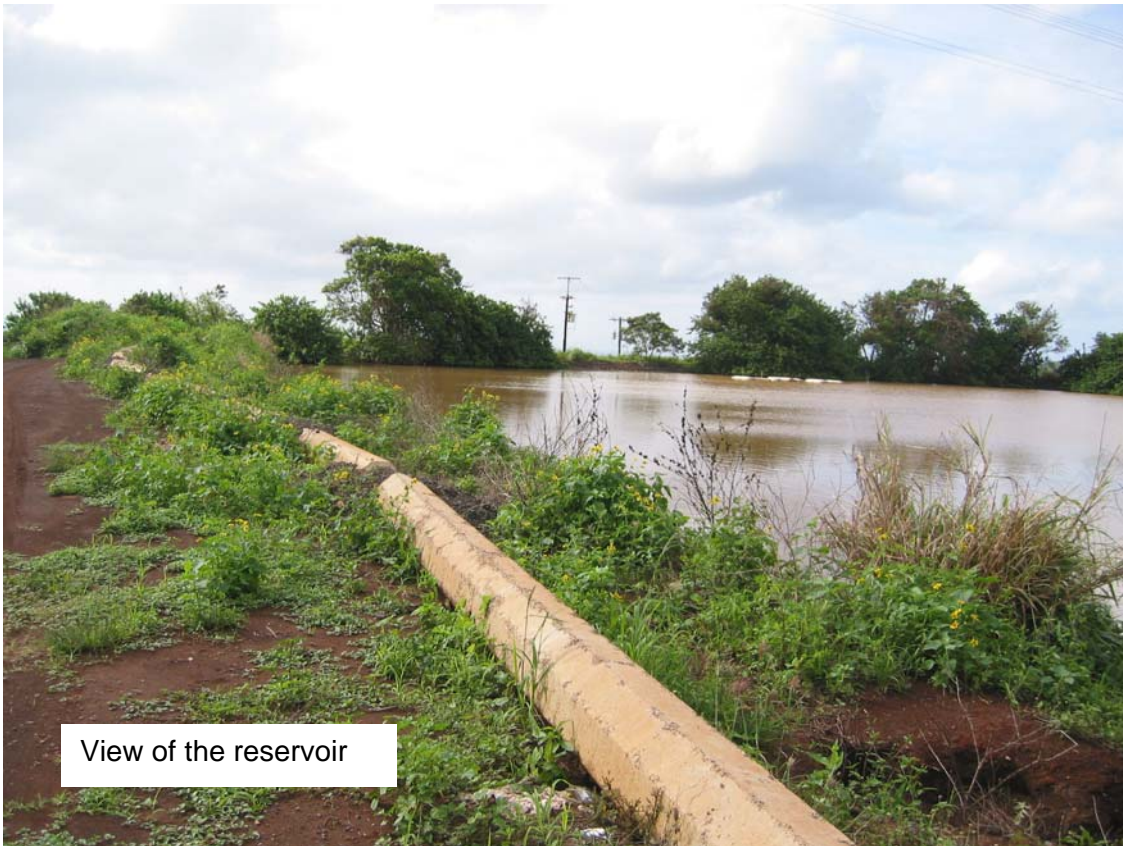
View of the reservoir

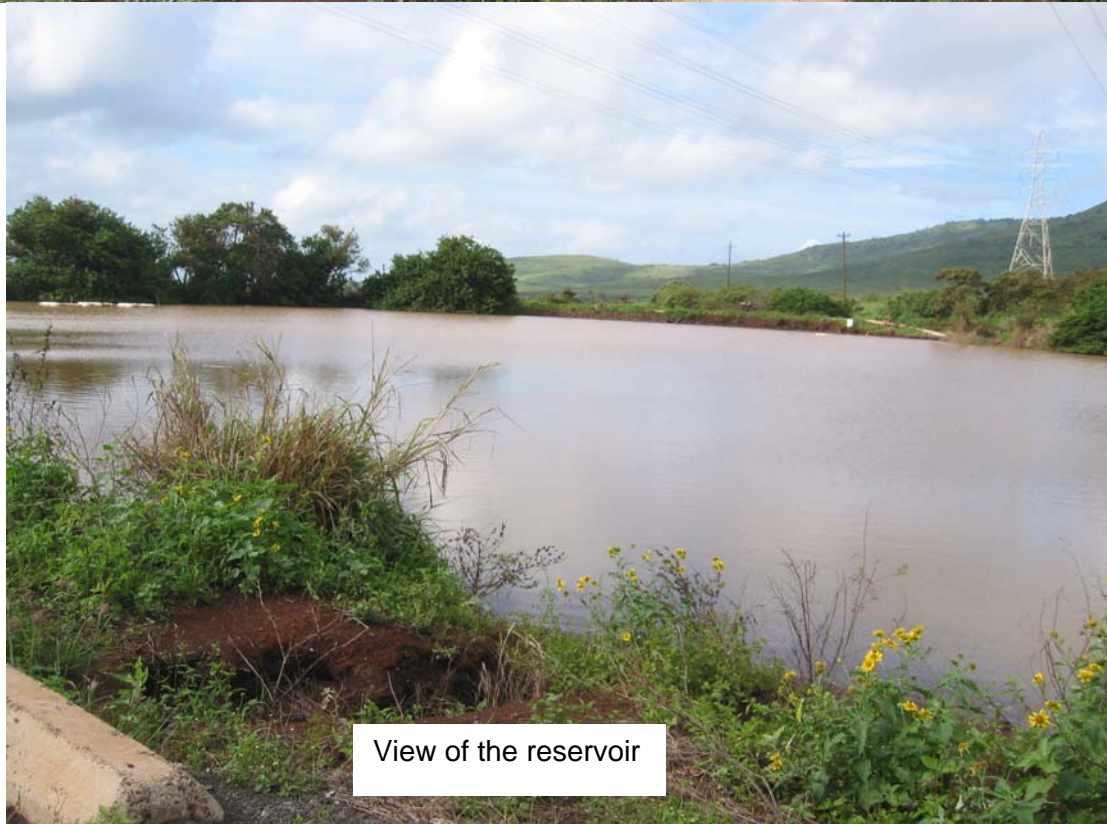
View of the reservoir

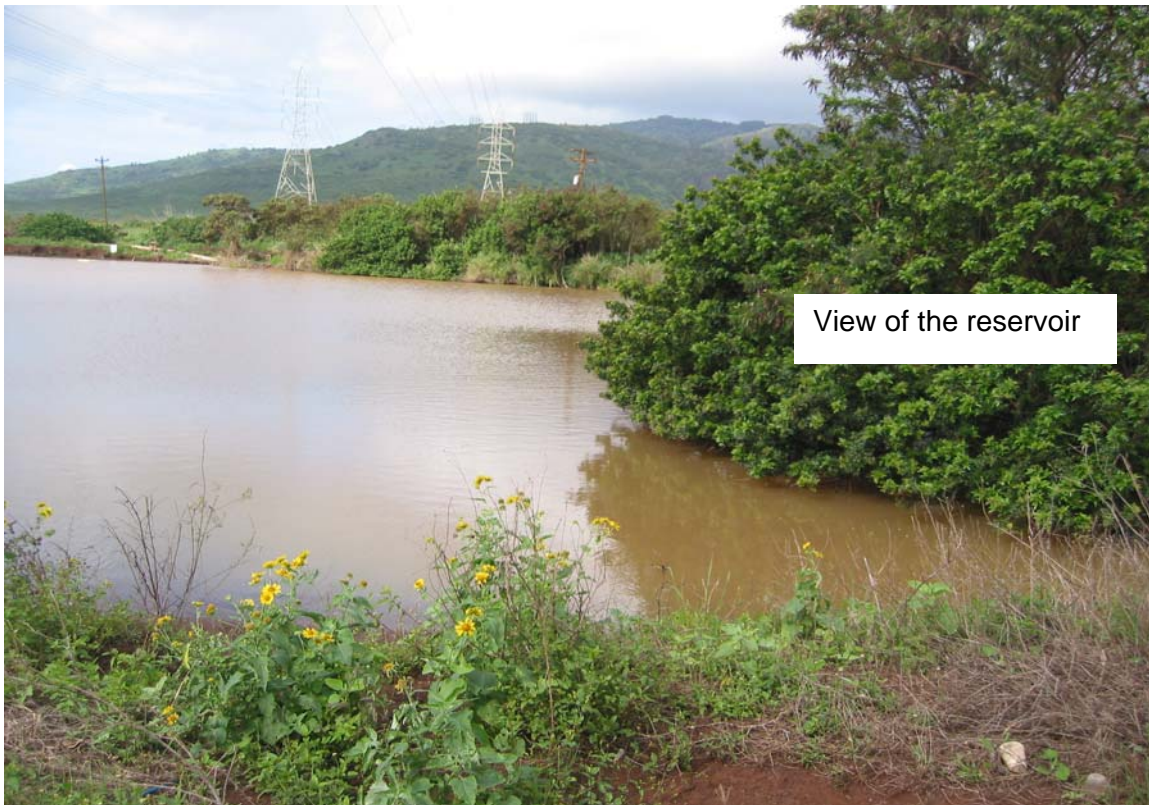
View of the reservoir

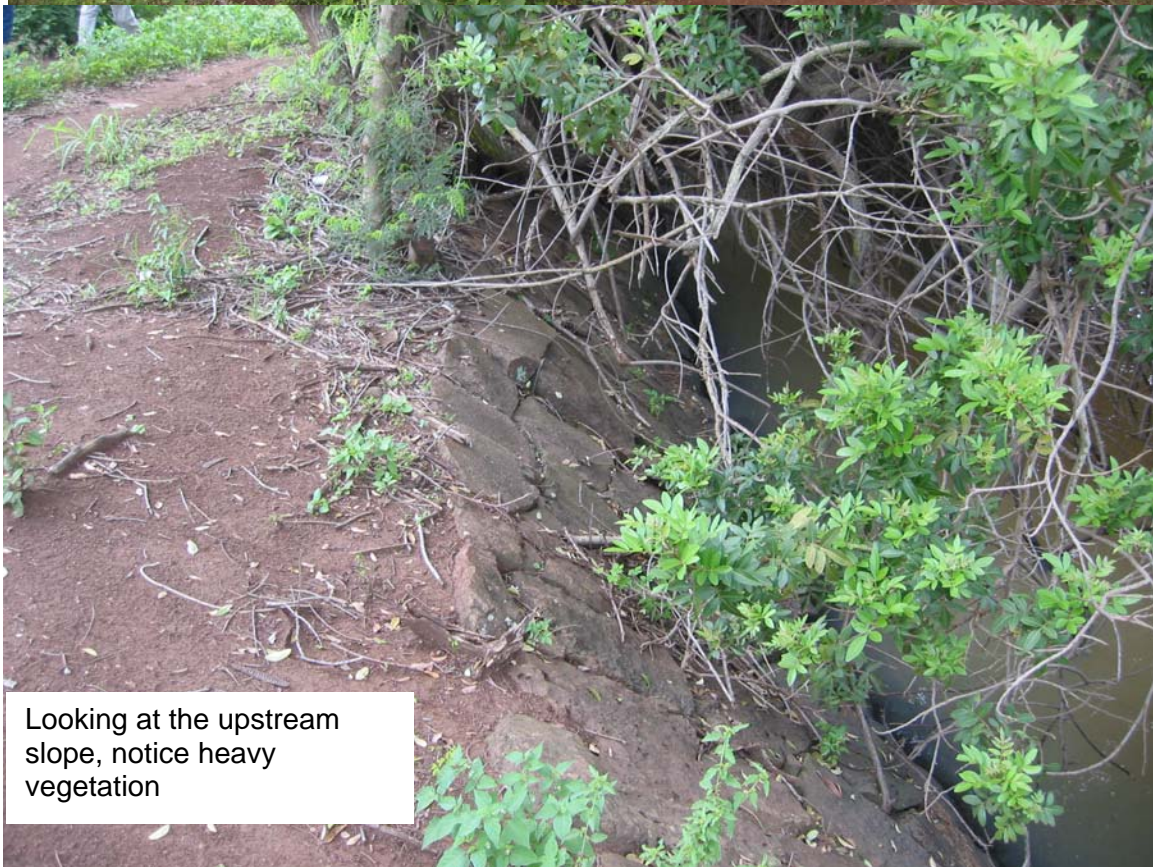
A fitted rip rap rock slope protection was observed. Vegetation was observed growing between the rocks. Erosions of ruts < 6 inches were observed.

- a. The upstream slope appeared to be in fair to poor condition and requires corrective action.
- b. Rut and/or Gully erosion was observed on the slope, which requires maintenance and/or repair. Description: <6 inches

- d. Trees were observed on the dam embankment. Trees have been identified as the probable cause of piping failures, and can possibly cause severe damage to the embankment if they are uprooted during a high winds. Corrective action is required to remove the tree hazards from the dam. Acceptable remedies include removal of the tree and its root structure down to a 2" diameter and reconstructing the damaged embankment section. All repair work shall be accomplished as per the requirements of licensed geotechnical or structural engineer. Routinely monitor the damaged area for signs of settlement and seepage.

Looking at the upstream slope, notice heavy vegetation

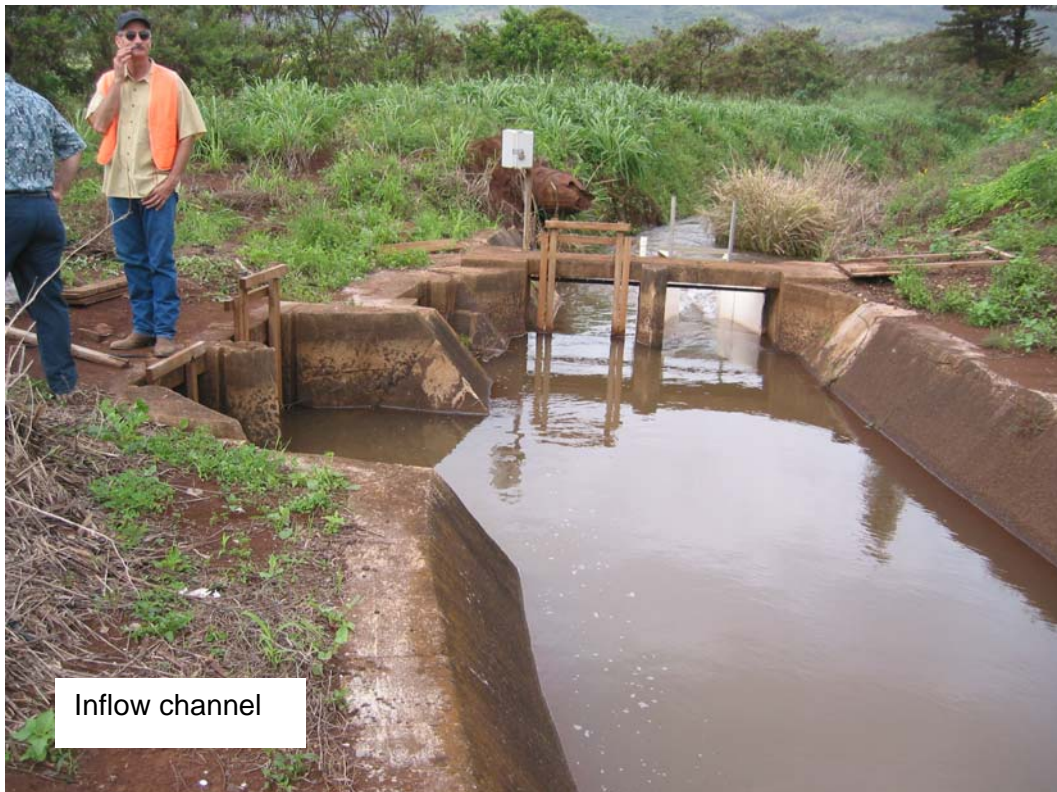
Inflow channel

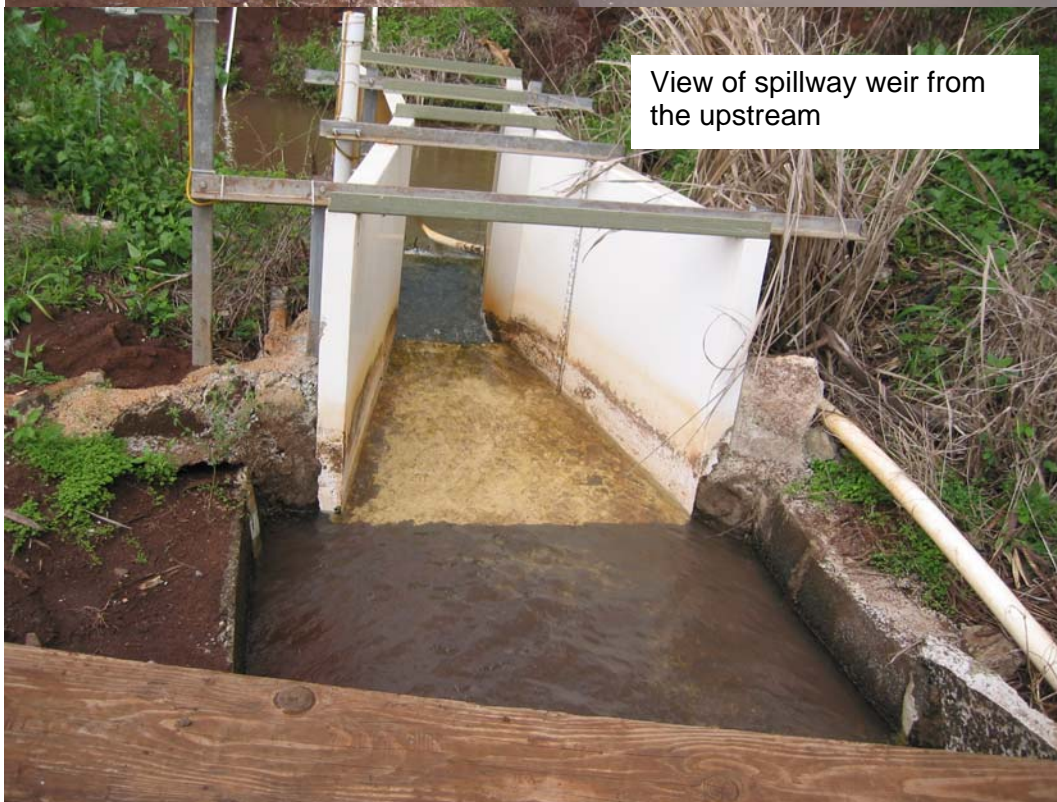
View of spillway weir from the upstream

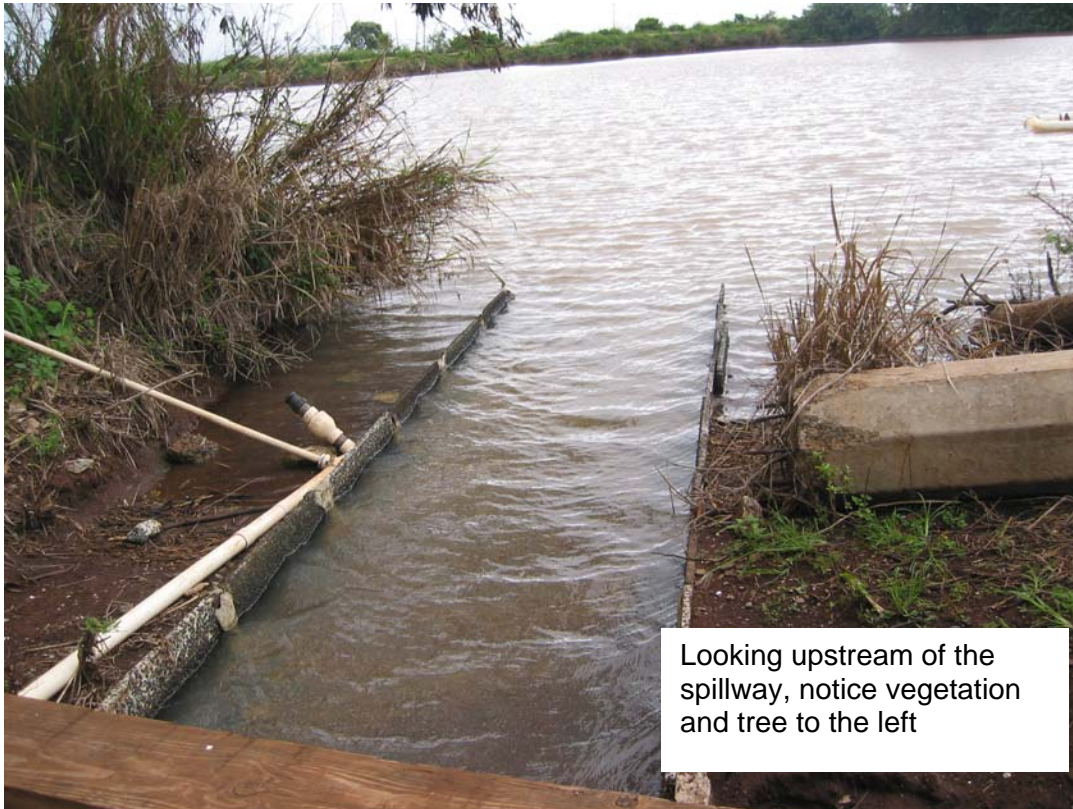
Looking upstream of the spillway, notice vegetation and tree to the left

- a. The Spillway appeared to be in satisfactory condition, no corrective actions are required at this time.
- b. Clear vegetation and one tree located at the spillway approach that could block the channel if it fell.

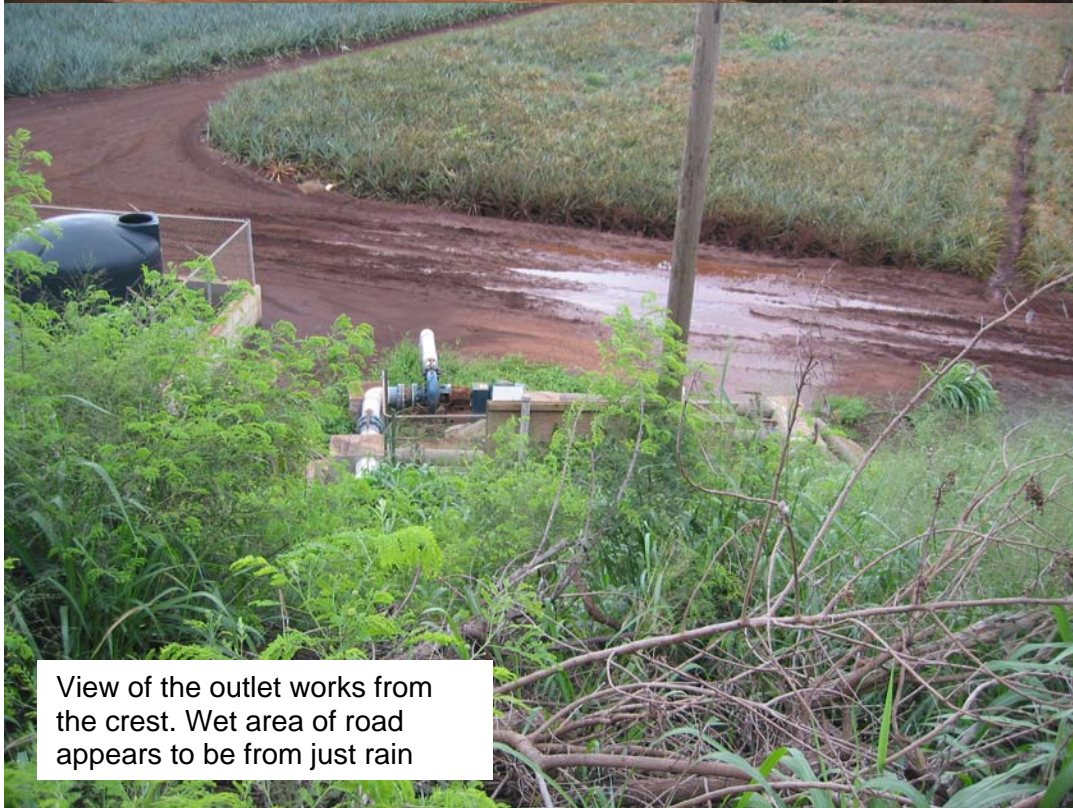
- a. The outlet works appeared to be in satisfactory condition, no corrective actions are required at this time.

View of the outlet works from the crest. Wet area of road appears to be from just rain
